GENERAL MAINTENANCE GUIDE

BC-Series

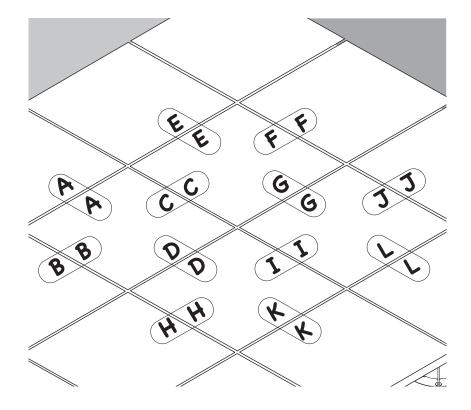
Example: Image 1

- Pavers might have been removed before and might not have been correctly re-installed following Buzon installation procedures (Please refer to image I shown on bottom of this page)
- Shims might have been removed, or were not used; Spacer tabs might have been removed, broken or not used.
- Buzon Pedestals might not have been re-installed correctly, following the installation procedures.
- · Combination of the above.

To gain access underneath the terrace, please ensure that any paver(s) taken out are first properly marked, this to ensure that the pavers are correctly re-installed, in the correct location and direction (rotation) of the paver. It is recommended that for each paver, the direction (rotation) and location are marked on each paver,

IMPORTANT: when taking out a paver from the terrace, it is always necessary to take the necessary measures to be sure that the paver is placed back in the same direction and position. For that, it is recommended, before removing any paver, to number each paver at each side of the paver, and mark with this the direction of the paver. Each paver can then be easily be placed back in its original location and rotation. Any rotation or changing the location of the pavers might result in improper alignment of the pavers and instability of the pavers on the pedestals
